Restoration of the decoration in the Atrio Quadrato

Doge's Palace

Information concerning the state of conservation

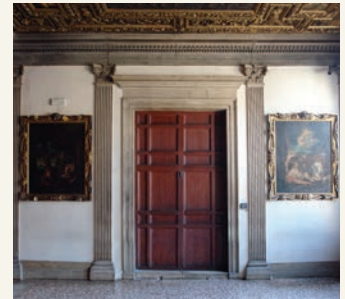
Atrio Quadrato, south side

The stone surfaces have a dark, thin and rather compact layer that blurs them: these are the result of the combination of incoherent surface deposits and old and now altered treatments, and they create an effect of widespread greying that flattens the high reliefs. There are also some localised fractures, particularly in the lower zone, resulting from blows. The wooden surface of the ceiling has a blurring caused mostly by badly adhering deposits. There are some areas of missing paint and localised lifting of gilding in the form of flakes that are near to falling. The painted canvases are overall in a good state of conservation and require a careful and close inspection to plan a more detailed intervention if required.

Stone surfaces: checking of the surfaces for presence of any loose parts; removal of loose deposits to be effected dry using soft bristle brushes and vacuum cleaners; passivation of the pins or clamps present with a subsequent addition of protective resin; removal of firmly-adhered surface deposits by washing with deionised water and soft sponges; checking of any stucco work with removal and rebuilding of those detached or unsafe as required.

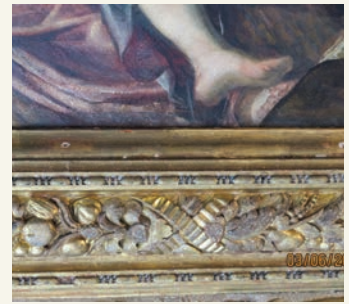
Gilt wooden surfaces: checking of the surfaces and consolidation of any loose parts with appropriate methods to be defined; removal of loose dust deposits done dry, with soft bristle brushes and vacuum cleaners; treatment of metal parts such as clamps or pins; checking for the presence of xylophagous attacks and woodworm treatment if required.

Detail of the morphological degeneration of the gilt wooden surfaces

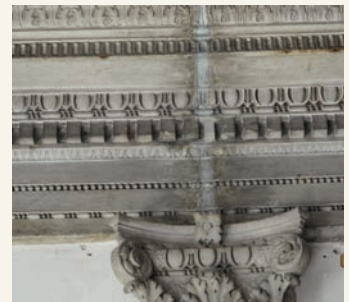
Detail of the morphological degeneration of the stone surfaces

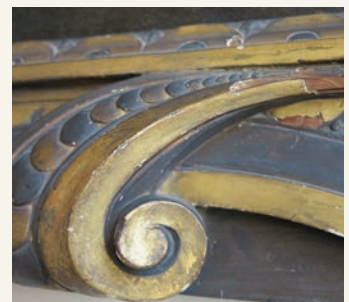
Detail of the morphological degeneration of the gilt wooden surfaces

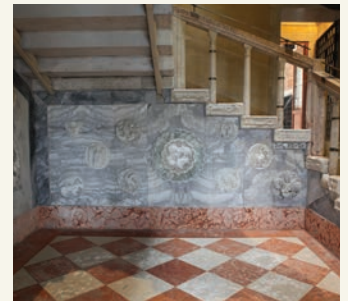
Overall view of the main staircase

The fine staircase that is the subject of this restoration project overlooks the portico on the Grand Canal. It was rebuilt by Berchet in the place where there used to be an old roofed staircase; its well shape is intentional so that the central void in the shape of a truncated pyramid could spread the light coming from above more widely. To maintain this layout, the highest ramps are longer and

The state of conservation of the staircase is strongly affected by damp from two sources: from capillary ascent and from condensation, which occur mainly on the stone cladding of the base walls and on the first flight of stairs. In line with the well-known mechanisms of decay triggered by the crystallisation of salts, the surfaces of polychrome marble presents the entire gamut of morphologies of deterioration (exfoliation, descaling, pulverisation, detachment) which has already given caused the partial loss of the original modelling especially on the pateras in basrelief. Moreover, there are also signs of cracking of the slabs and detachment and gaps in the plasterwork on the first flight of stairs. The Istrian stone steps not only reveal the normal depressions due to wear from the passage of many feet, but also a pronounced differential alteration caused by the stone's clay veins being hollowed out, and this sometimes poses a danger to the safety of visitors in transit.

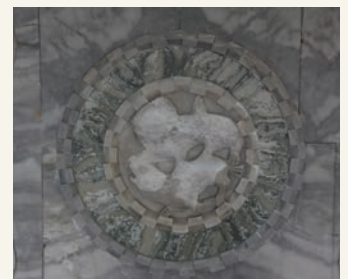
Detail of an ancient crystal marble patera with advanced degradation

On the ground floor, the base walls of the staircase are decorated with panels of polychrome marble in which are embedded 15 paterae. The marble is for the most part Proconnesian and Lunense, followed by Breccia Medicea, green Cipollino and Bardiglio. The paterae are all carved from crystalline marble with the exception of one. According to Rizzi, these are nineteenth-century imitations except for two of them, which are allegedly original, albeit very deteriorated; it is suggested that these originals are two of the paterae on the east wall, but this hypothesis will need to be checked by a more thorough investigation.

The plan of action includes: dismantling the decorations in polychrome marble to effect a desalinisation and consolidation off site; cleaning and consolidation of the wall supporting the staircase; subsequent reassembly of the restored marble decoration with a system which provides for the isolation from the masonry behind in such a way as to reduce or eliminate the intake of water from the support wall. The planned project does not require the use of temporary structures and only the first flight of the staircase will be closed during part of the work. The project will also include the consolidation and checking of the marmorino plasterwork of the side wall on the first flight.

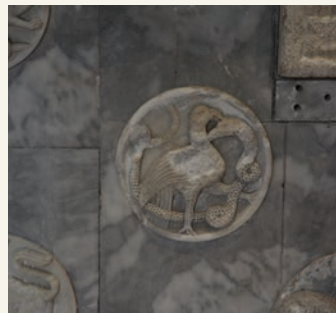
Detail of an ancient crystal marble patera with advanced degradation

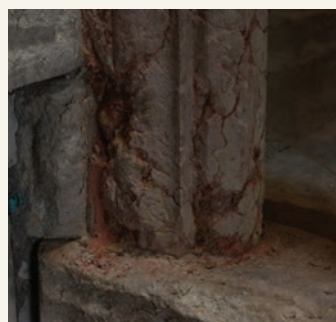
Detail of a degraded limestone "rosso Verona"

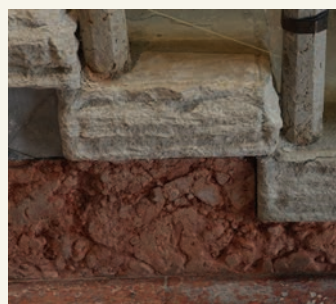
Detail of a degraded limestone "rosso Verona"

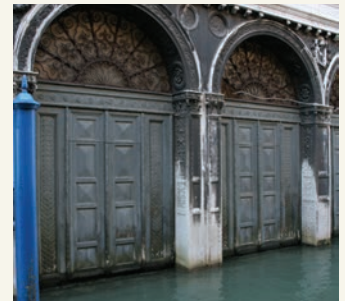
Wooden nineteenth century doors before the dismantle for the restoration in 2007

The wooden surfaces presents cracking on the successive painted surfaces of the front and rear, and localised rot, principally on the decorated reliefs.

Bottom View of the doors, the degradation of the wood is visible due to the attack of micro - marine organisms

A height was identified, for the slit and it was planned to cut the portion of the doors at front and rear at this level to restore the eroded and rotting parts. The missing portions will be reconstructed following the manner of the original work but using different wood: in particular, the tropical species Azobè will be used for the inner core and seasoned oak for the added reliefs and decorated parts.

All the exterior surfaces will be treated by removal of earlier layers of paint, treatment of disin-festation, local consolidation of deteriorated wooden parts by impregnation with acrylic solutions, pinning of rotting portions, integration of missing parts decorated in low and high relief, preventive treatments and final painting.

The metal parts will be treated and recovered, and missing bolts and parts will be replaced by polished AISI 316 stainless steel bolts. The lower hinges inserted in the stone jambs will be extracted and replaced with AISI 316 stainless steel ones and a new hinge will be inserted where the greatest size of the lower parts requires it because of the weight of the part that needs to open and close.

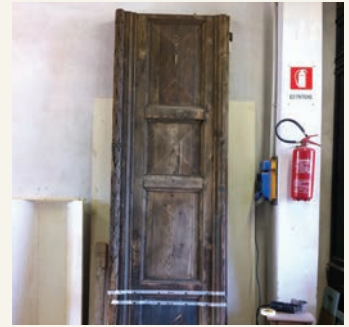
Front view of a door with an indication of the cut to be made for rehabilitation

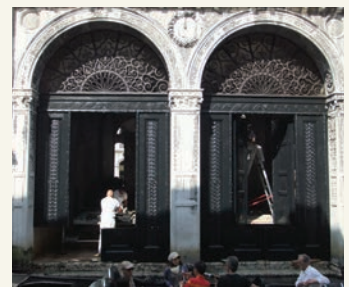
View of the twin gates already restored during their reassemble in place. The new selective opening mechanism of the various parts, resulting from the cut of the lower portions and the insertion of new independent portions, is visible

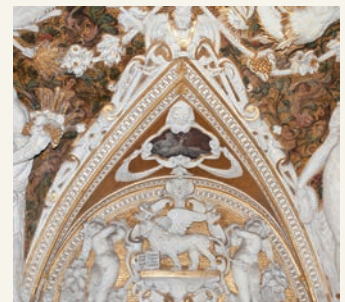
Detail of one of the lunettes decorated with polychrome stucco

As with the wall paintings, so the stucco is also greatly altered in terms of legibility, as result of overpainting in white. In numerous areas, the modelling has been reworked. In view of the overhangs and weight of the decorations, a timely control of the entire surface is to be recommended, taking into account the problematic conservation history of the ceiling.

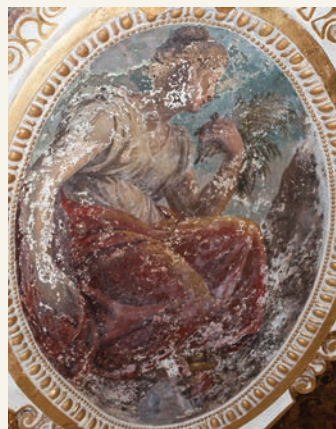
Detail of one of the murals with evidence of the present degradation morphologies

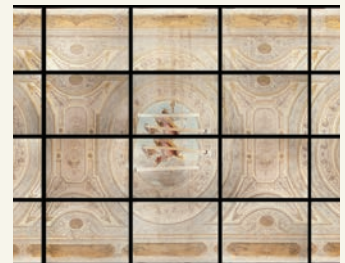
Photomosaic of the decorated ceiling at the end of the first campaign of interventions that affected the paint surface

The conservation problems of the decorated ceiling in the Sala Papadopoli concern a pronounced detachment of the wattle support from the wooden beams supporting the attic above, a phenomenon which became evident in the aftermath of a major structural intervention to replace a certain number of rotting wooden beams with new ones. At the end of a first campaign of investigation and restoration of just the painted surface, a temporary restraining system was put in place consisting of Plexiglas panels and steel screws that assure retention by lumps to the central band of the ceiling (an area of about 3 * 5 meters); this is an area that the investigation showed to be the most affected by the sagging. The restoration of the painted surface except for the central tondo has been completed.

The maintenance work includes the consolidation of the extrados of the decorated ceiling from the room above the Sala Papadopoli after removing a portion of the existing flooring. On the basis of endoscopic investigations conducted during the first campaign of intrados restorations, it was possible to narrow the area of the decorated ceiling subject to sagging, which was caused by the rupture of the original rope ties suspending the wattle from the overlying wooden beams. The project will consist, therefore, in the progressive removal of the flooring of the room above and the consolidation of the extrados by reworking the tresses supporting the wattle and a subsequent transverse support in bands of basalt fibre laid on mortar. At the end of the extrados consolidation, the intrados will be completed by terminating the restoration of the paintings in the central decorated portion and removing some of the panels placed as a precautionary measure.

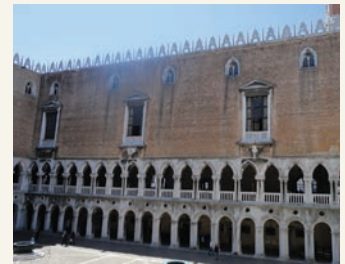
View of the west façade overlooking the internal court

The west façade of the inner courtyard is in a poor state of repair and was recently the subject of localised precautionary operations undertaken with the help of restorers working from suspended ropes. The huge wall constituting the upper register presents numerous critical points due to the poor condition of the mortar and bricks that have in previous years caused the infiltration of water at the points supporting the wooden truss systems of the portico. Moreover, making considerations in analogy to what has already been observed during the restoration of the adjoining façade (Maggior Consiglio), we may assume that in the floor of the Sala dello Scrutinio there are the same metal bolts of metal trusses which, as a result of corrosion, cause tensions on brick panelling. Another critical element is the upper stone mullioned windows enclosed by metal frames with leaded glass. These have been the subject of temporary precautionary work, consisting of the positioning of steel nets to hold back any detachment of disintegrated stone material or portions of frame. Much more widespread is the considerable dirt and organic deposits that affect all the materials making up the façade, which require selective and controlled cleaning.

The project involves the total restoration of the façade, including the following categories of work: preliminary investigations, cleaning, structural consolidation, surface consolidation, any replacements with new supplies, final protection. The intervention involves the use of large-scale temporary structures whose cost would make it uneconomical to divide the work into separate lots.

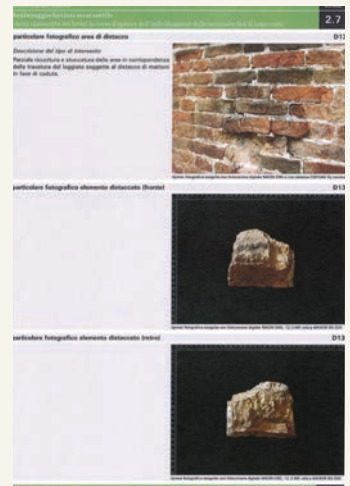
Detailed study of conservative critical issues on the façade

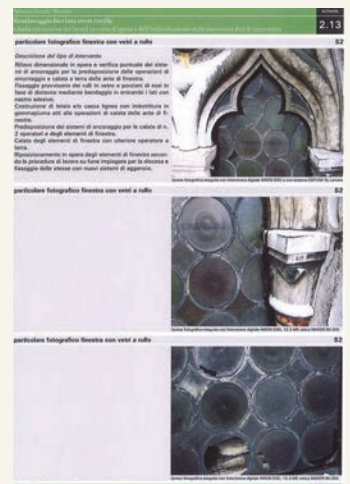
Detailed study of conservative critical issues on the façade

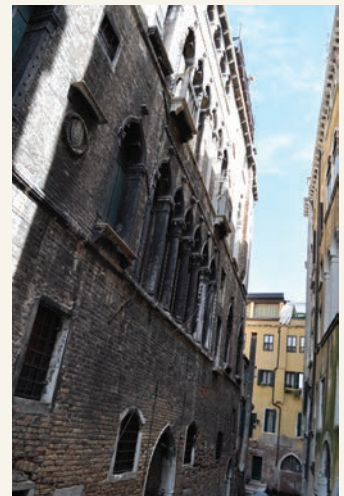
Glimpse View of the façade on the rio of Palazzo Fortuny

The imposing façade overlooking the canal of Ca' Michiel is in poor condition mainly because of the natural deterioration of the Istrian stone elements that make up much of the façade. This type of stone, widely used on the façades of the city’s buildings can, depending on the degree of homogeneity resulting from the original sedimentation processes, develop types of decay including the hollowing out of clay veins within the stone and thus a differential alteration, generating sudden detachment of even large portions of material. This phenomenon constitutes a serious risk not only for the preservation of the monument but also for public safety.

Another form of decay is that to be found on the glazed window frames of the openings, many of which have typical leaded glass windows which require disassembly and unbinding for a full recovery of the original glass.

The project involves the total restoration of the façade, including the following categories of work: preliminary investigations, cleaning, structural consolidation, surface consolidation, any replacement with new supplies, final protection. The intervention presupposes the use of temporary large-scale structures hanging over the canal, whose cost and logistical complexity would make it uneconomical to effect the work in separate lots.

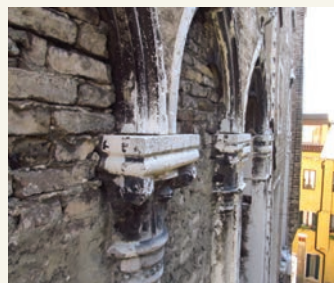
Detail of the mullioned window made of Istrian stone

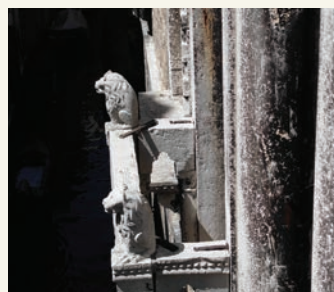
Detail of one of the balconies made of Istrian stone

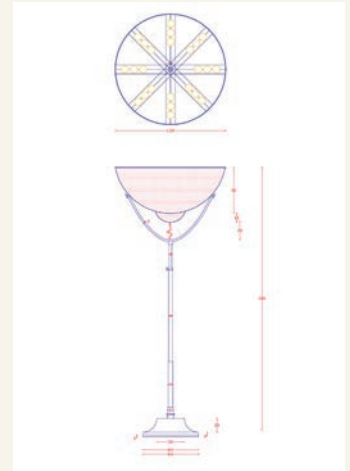
Layout of the new stand designed to hold a new generation of LED headlights with selective optical

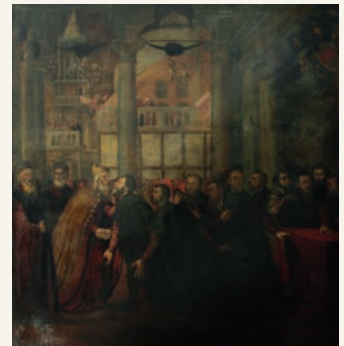
Doge Priuli and the Scuola dei Calegheri
by a Veneto painter

The painted surface has been greatly modified and darkened by sedimentation of dirt, from yellowing and oxidation of the protective varnish and by widespread whitish deposits of a crystalline structure that appear to be traces of materials poorly removed during earlier cleanings. In addition, and despite this thick layer, there are large dark patches that are old painted restorations that have changed in shade, together with a widespread condition of leaching and abrasion of the original pigment. The lower left corner is spotted by a whitish deposit of a material that was apparently splashed accidentally.

The paint itself reveals a generally good level of cohesion and adhesion to the support. The painting is supported by a stretcher constructed with expanding corners reinforced by a central cross; It appears in good condition and is still effective. There are a few woodworm holes and two wedges are missing.

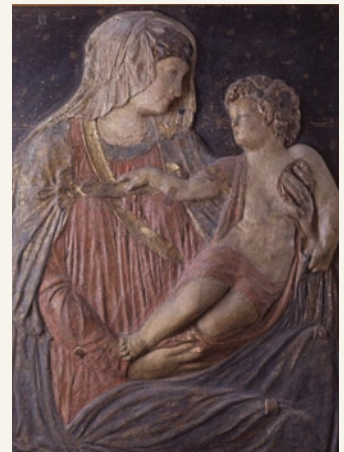
Jacopo Sansovino,
Madonna con Bambino

The state of conservation of the polychrome surface is dramatic. The fragility resulting from the materials of which the work is made has led to repeated more or less invasive interventions aiming to restore integrity to the surface and polychromy. In particular, the surface reveals fillings of various kinds, attributable to maintenance interventions at various times. A final drastic intervention, traces of which remain on the surface, went so far as to remodel the relief completely with a layer of stucco that is in some areas a few

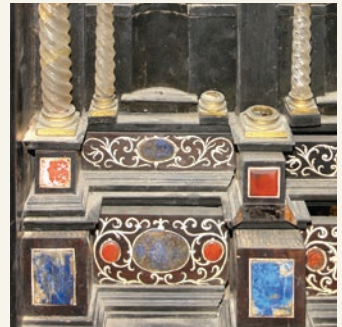
The terrible state of conservation of the cabinet is mainly the result of a serious xylophagous attack that has affected the whole structural part and the ebonised wood additions.

The temperature and humidity conditions of the premises in which it was stored for a time have led to a slight swelling of the wood, making it impossible to slide the drawers open. A layer of dust and random dirt completely covers the surfaces.
